Appendix B

Photos

Part I – Truss Spans

Part II – Kittery Approach Spans

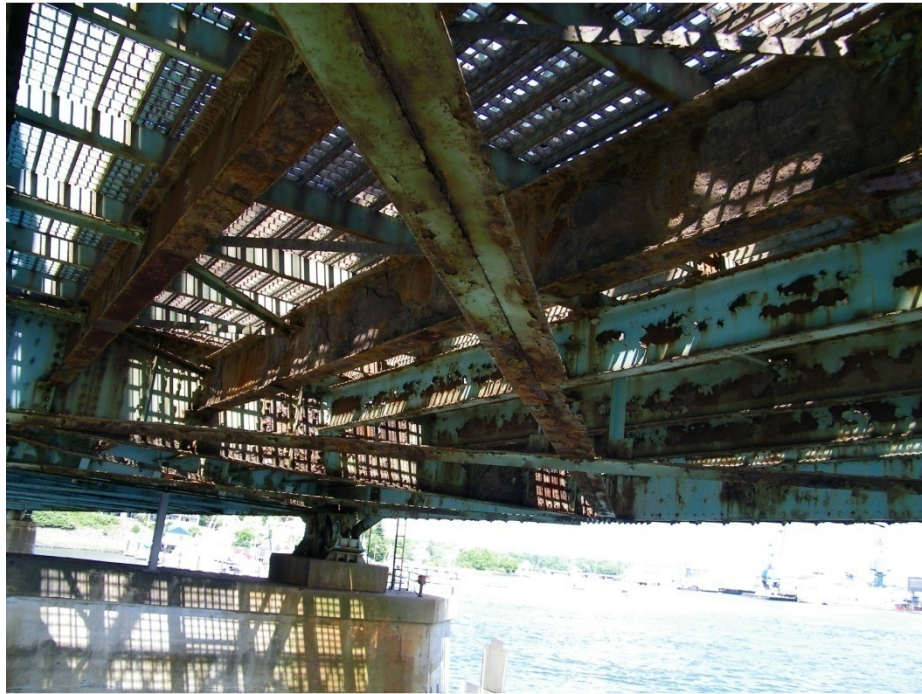
Photo 1.1: Underside of lift span at Bay 9, north. Stringer lines S4-S9 shown left to right. Typical deterioration of unrepaired stringers and bottom lateral bracing shown.

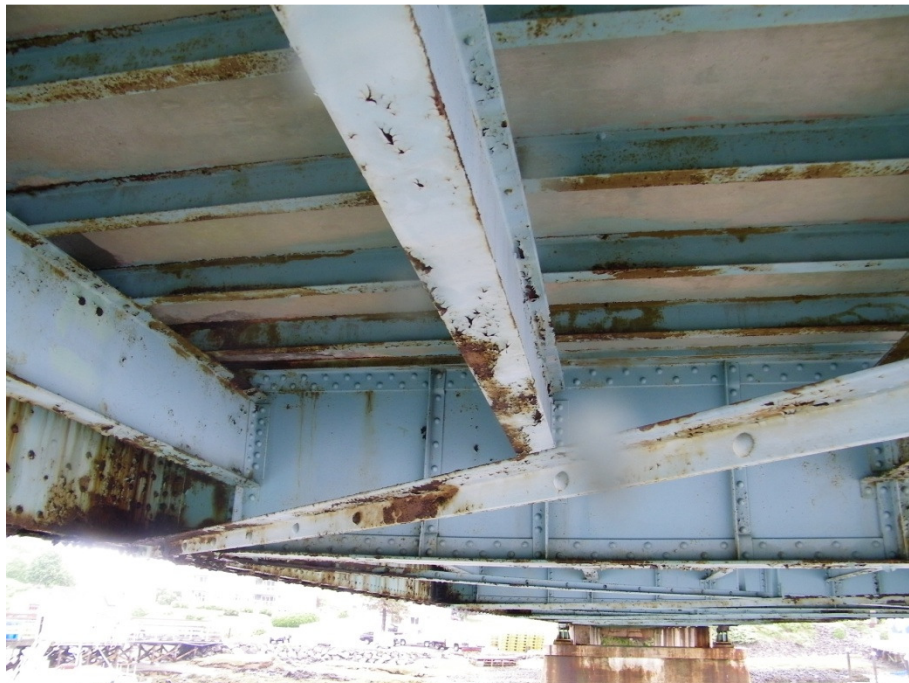
Photo 1.2: Underside of fixed Span 3, Bay 2. Surface rust on stringers, purlins and floorbeams typical in fixed truss spans.

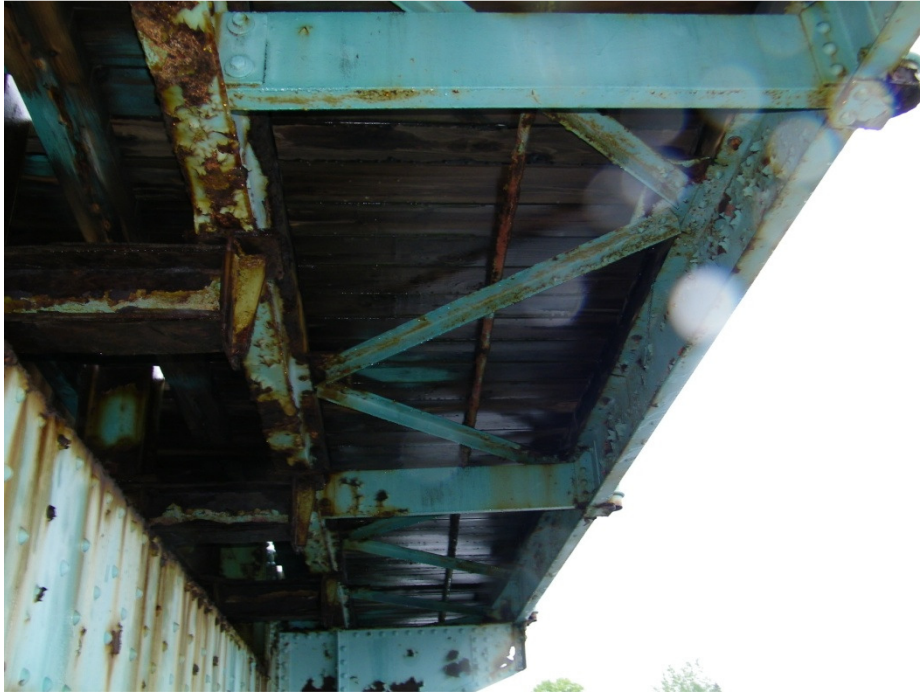
Photo 1.3 Underside of sidewalk overhang. Condition typical of all truss spans.

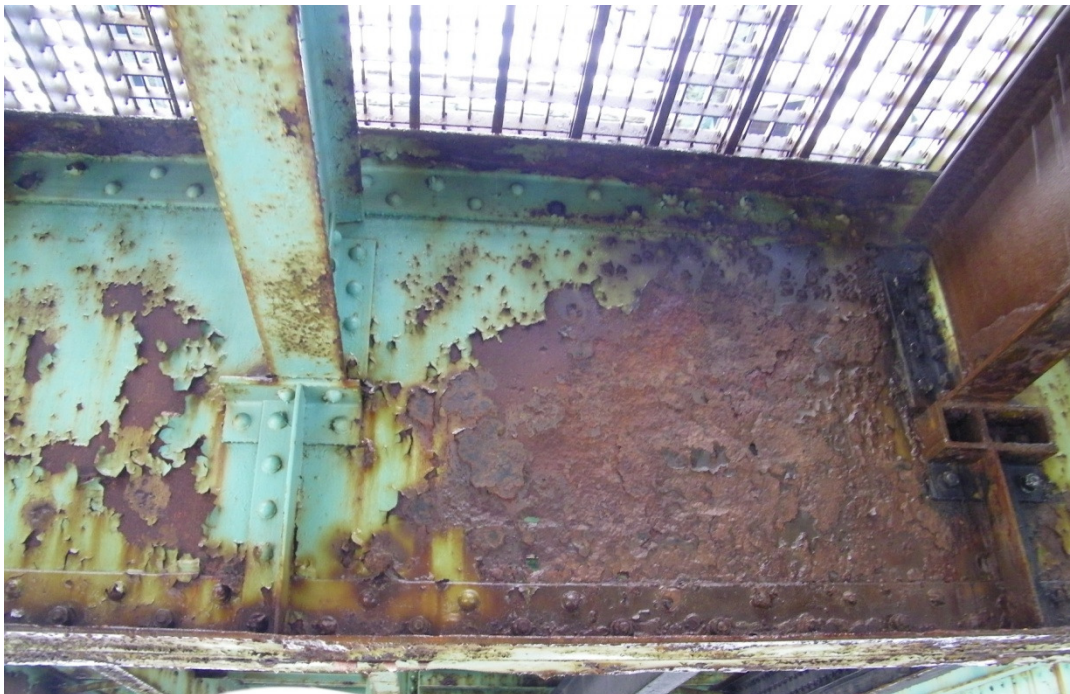
Photo 1.4: Span 2, Floorbeam FB7, north face, at Stringers S5 and S6. Laminar corrosion throughout web is common to all lift span floorbeams.

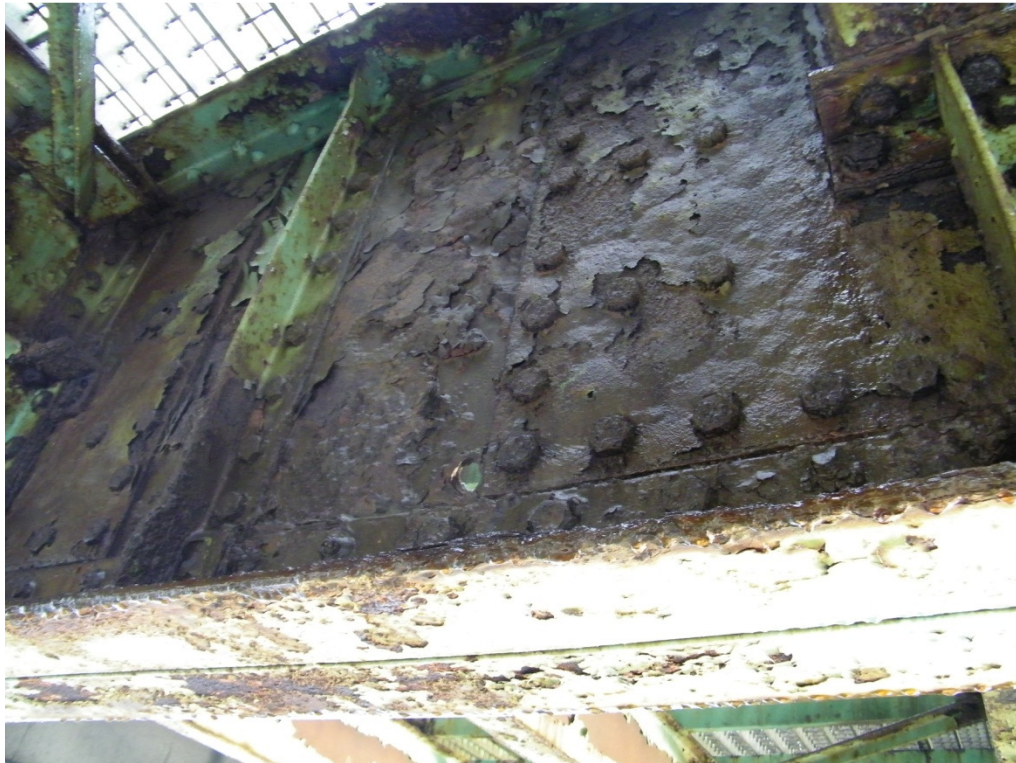
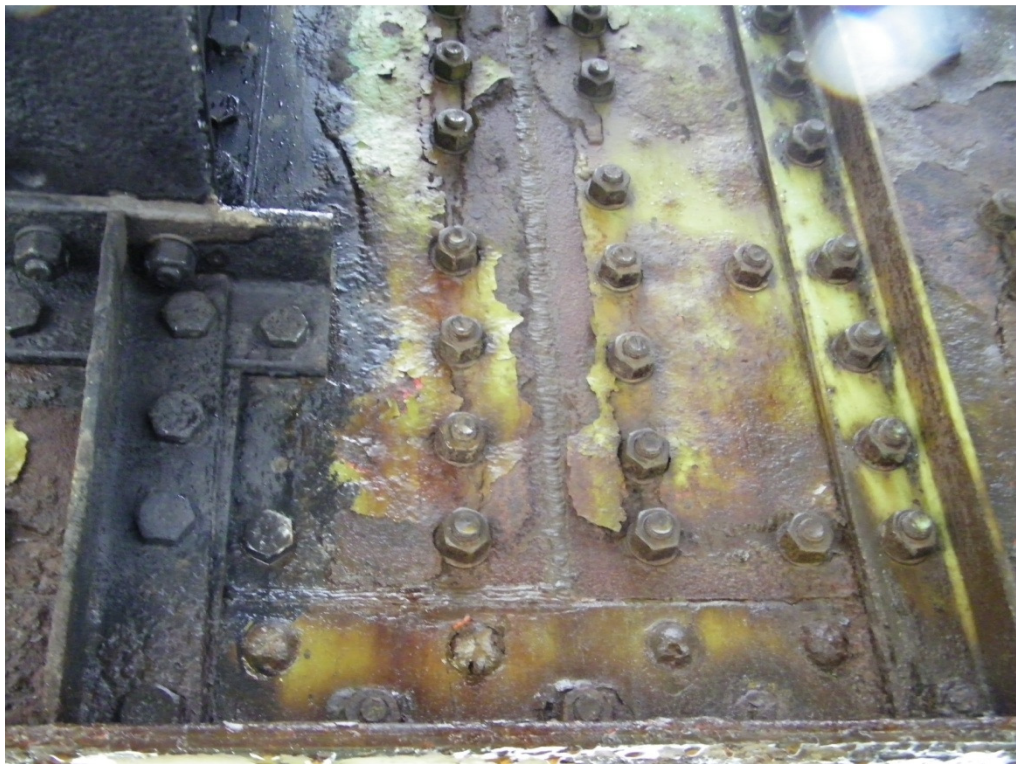
Photos 5 and 6: Span 2, Floorbeam FB6, south face. Laminar corrosion and heavy rust are typical of Span 2 floorbeam repairs. Repair plates welded together and to flange angle of floorbeam.

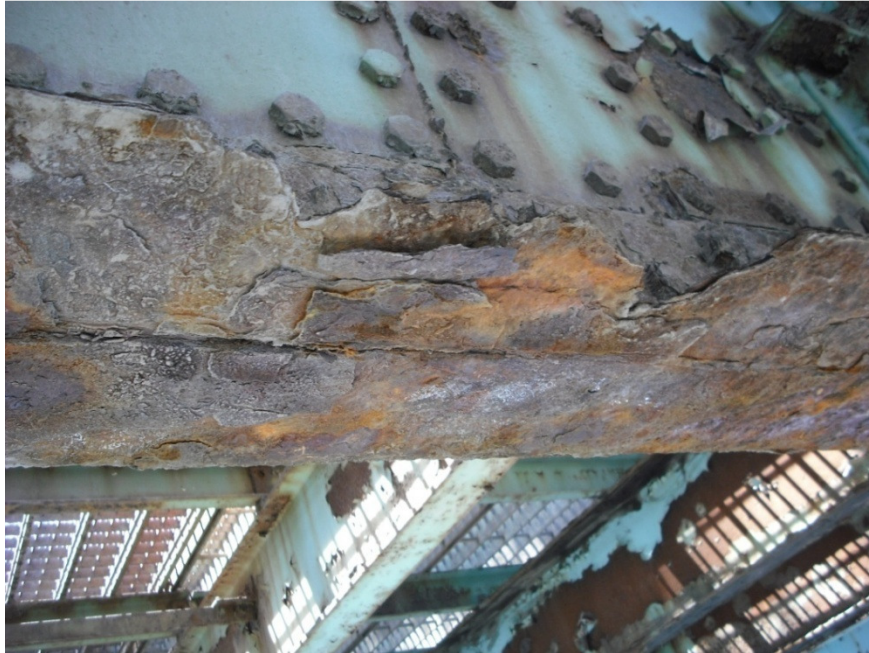
Photo 1.7: Span 2, Floorbeam FB2. Bottom flange heavily corroded. Half of flange has 100% section loss.

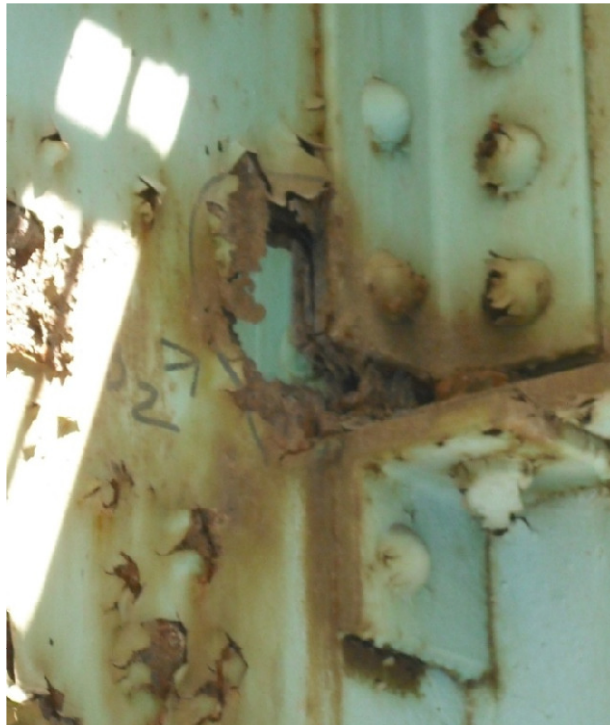
Photo 1.8: Corrosion hole on web of Span 2, Floorbeam FB1 at Stringer S4 connection.

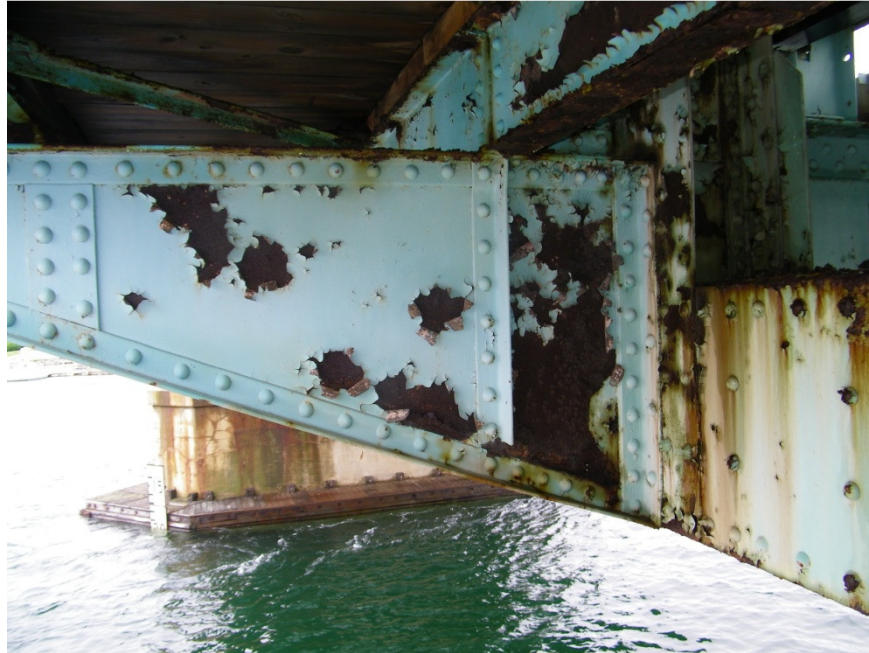
Photo 1.9: Span 2, Floorbeam FB6, west overhang. Laminar corrosion on overhang web and a 2" diameter corrosion hole on bottom of web at truss connection.

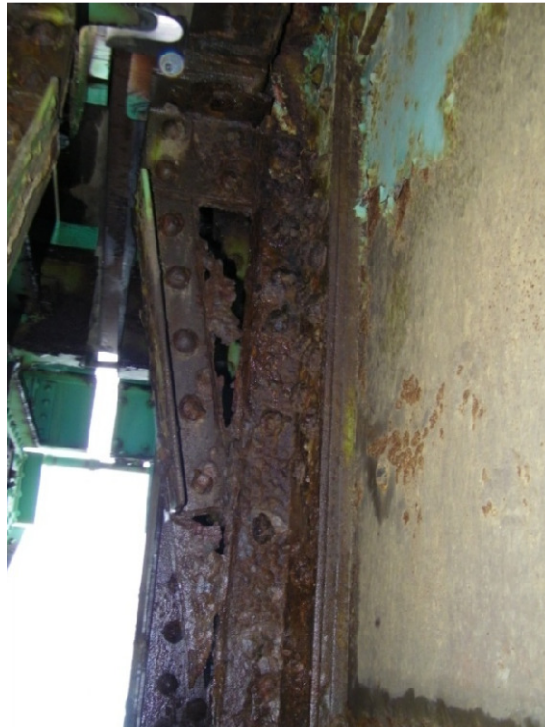
Photo 1.10: Span 3, Floorbeam FB10. Deck support attached to FB10 web is heavily corroded. This support is underneath the expansion joint.

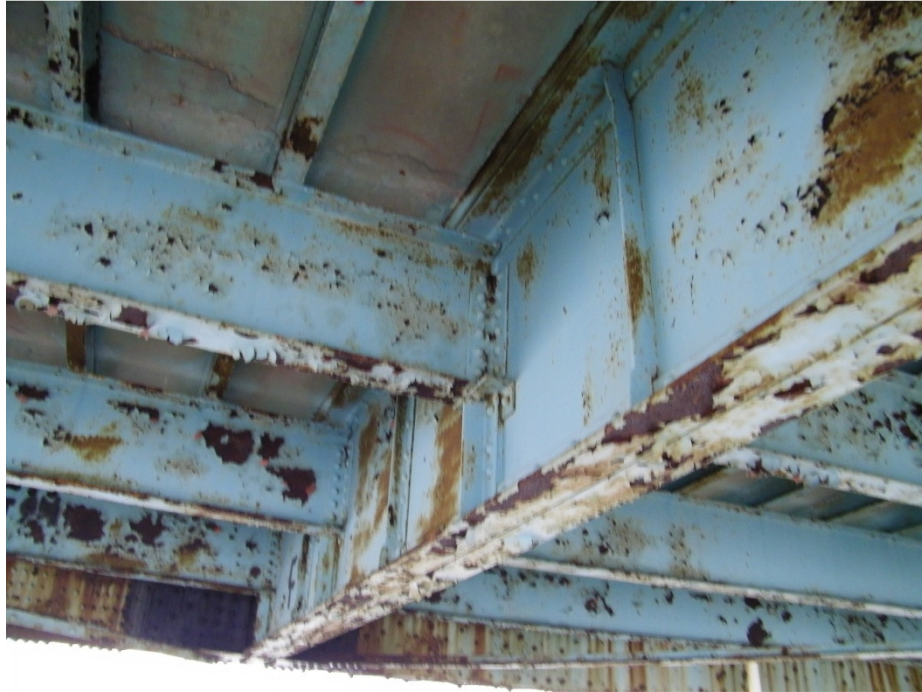
Photo 1.11: Span 1, Floorbeam FB6, north face. Surface rust typical of fixed span floorbeams.

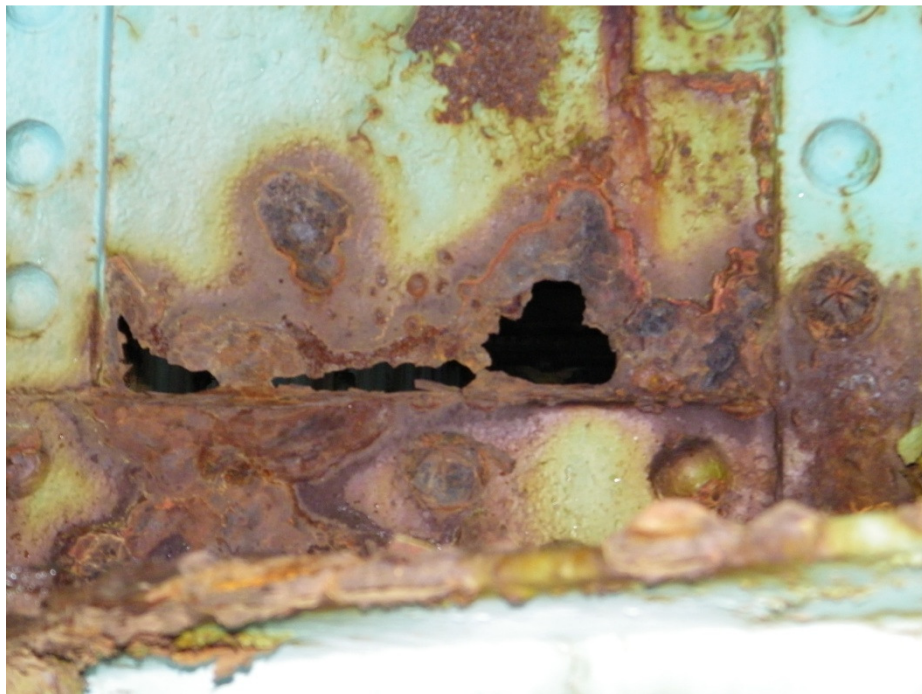
Photo 1.12: Span 1, Floorbeam F7. Approximately 16" wide corrosion hole on web at east end of floorbeam.

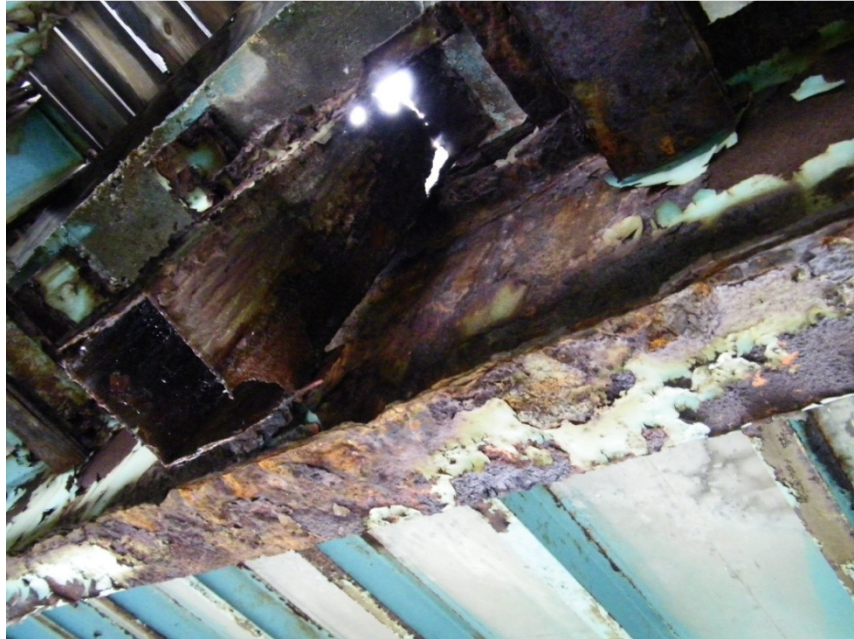
Photo 1.13: Span 1, Bay 6, Stringer S7 at downspout near midspan. Laminar corrosion, section loss, rust on all surfaces near downspout. Conditions typical of Stringer lines S3 and S7 at downspouts.

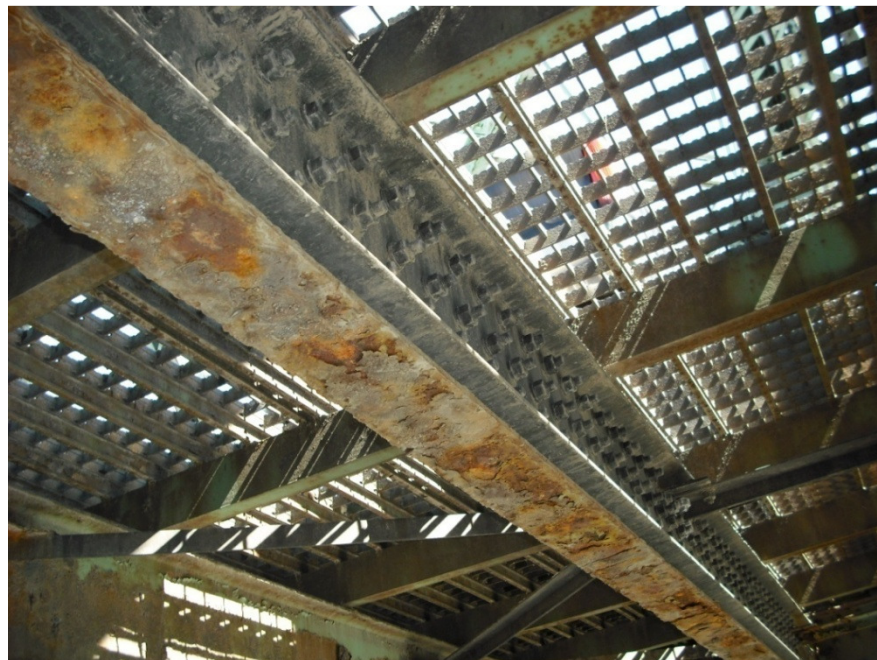
Photo 1.14: Span 2, Bay 1, Stringer S8. Deteriorated stringer repaired with 15" channels bolted to web on both sides of stringer. Condition typical of repaired stringers.

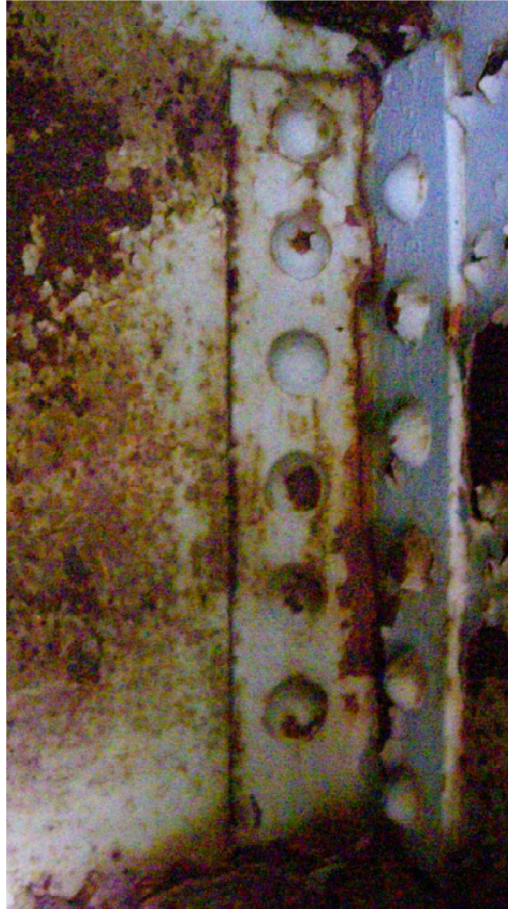
Photo 1.15: Span 1, Bay 7, Stringer 7 Connection to FB6. East connection angle has a 12 ⁷/₈" crack at the corner.

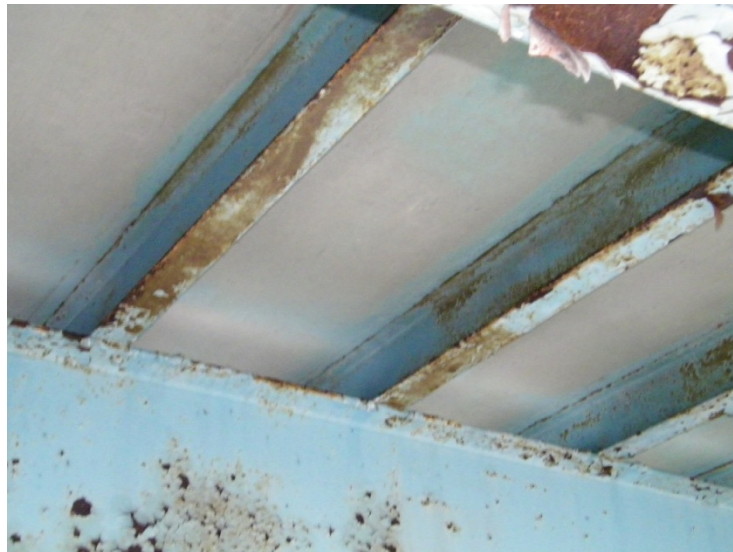
Photo 1.16: Span 1, Bay 6, Purlins at Stringer 4. Fixed span purlins have typical surface rust.

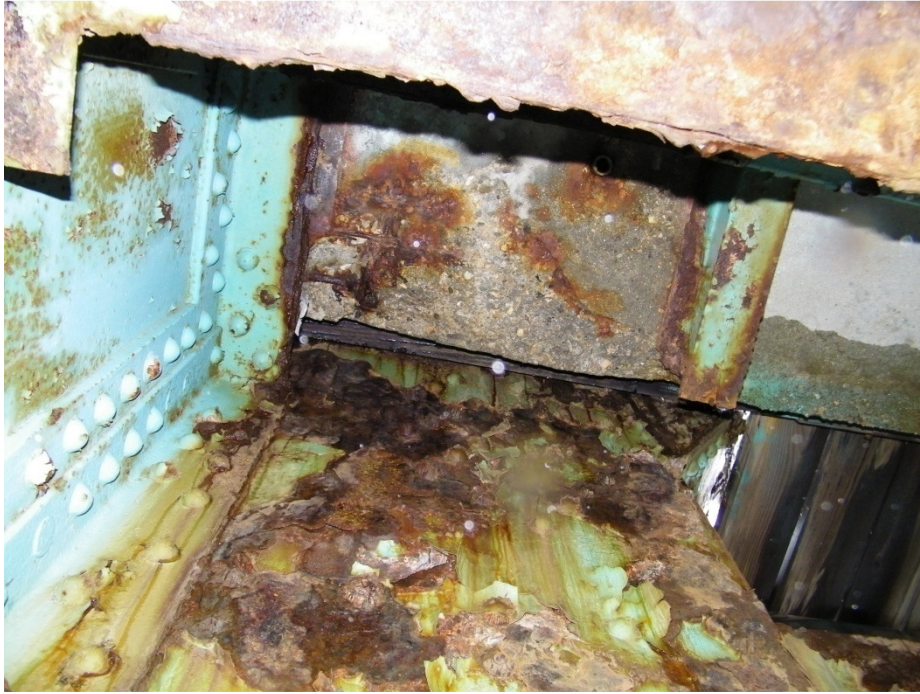
Photo 1.17: Span 1, Bay 8, east side of deck near Floorbeam FB8. Spall on underside of deck with corroded steel reinforcement.

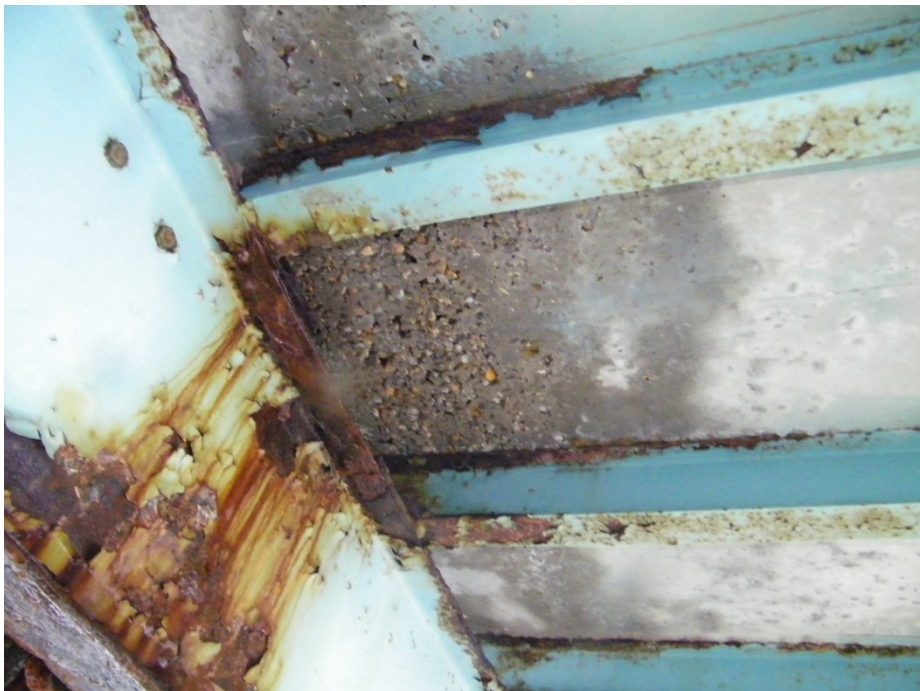
Photo 1.18: Span 3, Bay 6. Underside of deck honeycombing at downspout.

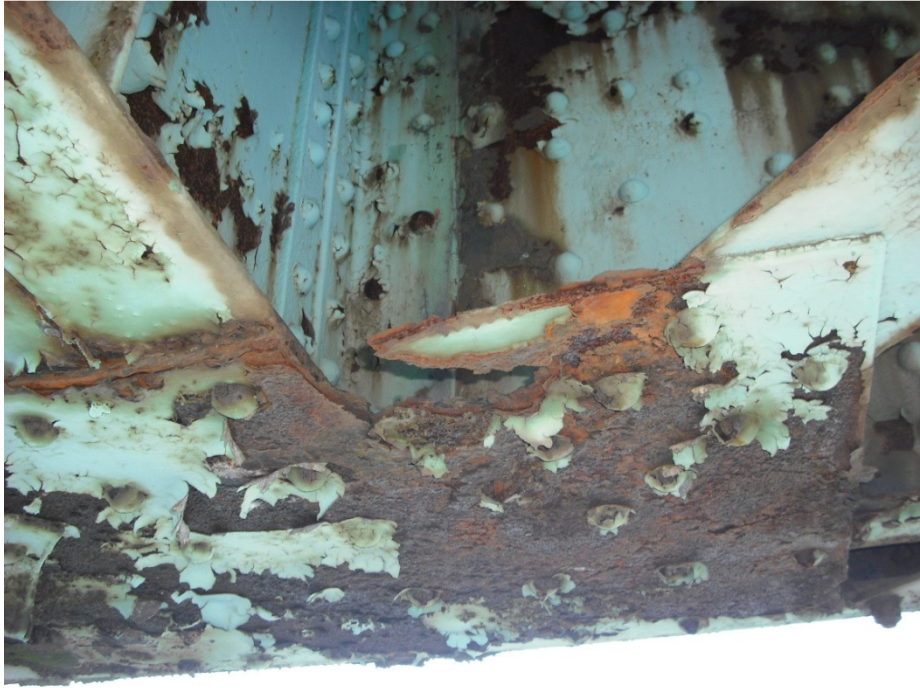
Photo 1.19: Span 2, Lateral gusset plate at L2E. Plate is corroded throughout with 100% section loss between the floorbeam and lateral bracing.

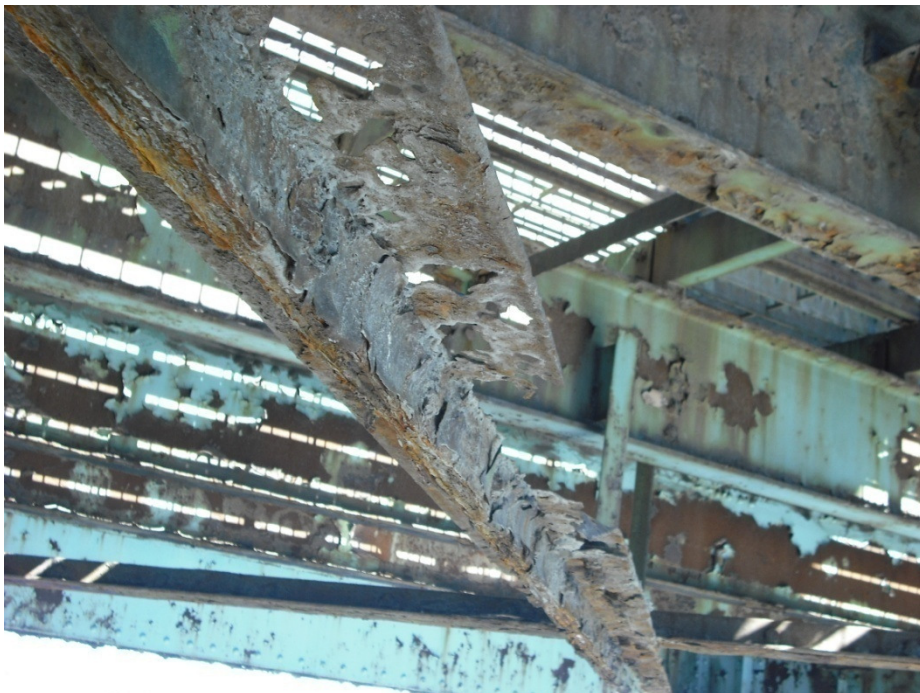
Photo 1.20: Span 2, Bay 1, Bottom Lateral Bracing. Bracing heavily deteriorated with almost 100% section loss in the horizontal leg of angles.

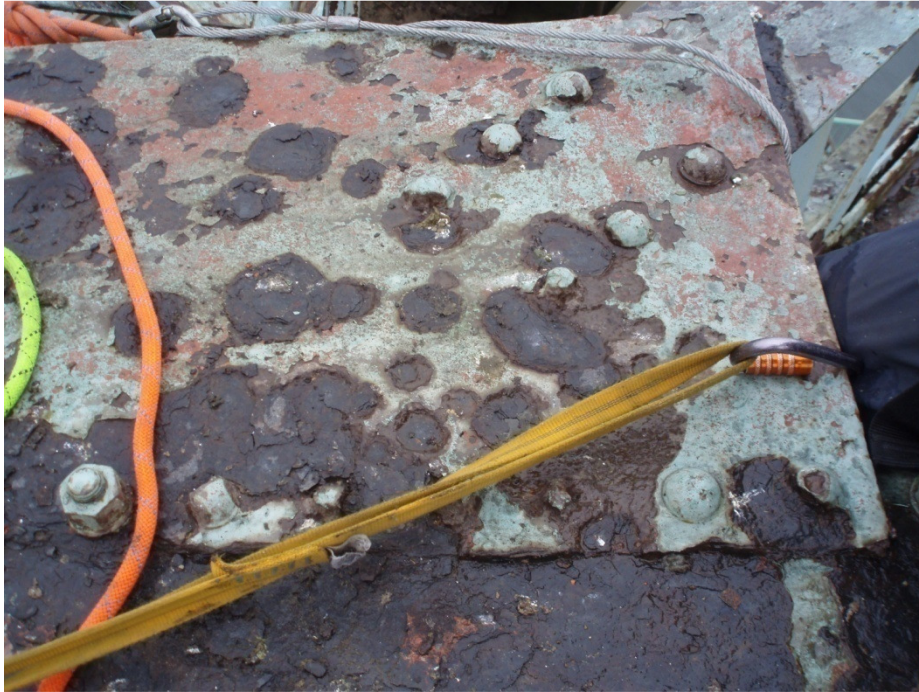
Photo 1.21: Span 2, Pitting and corrosion on Top Lateral Gusset Plate U0E.

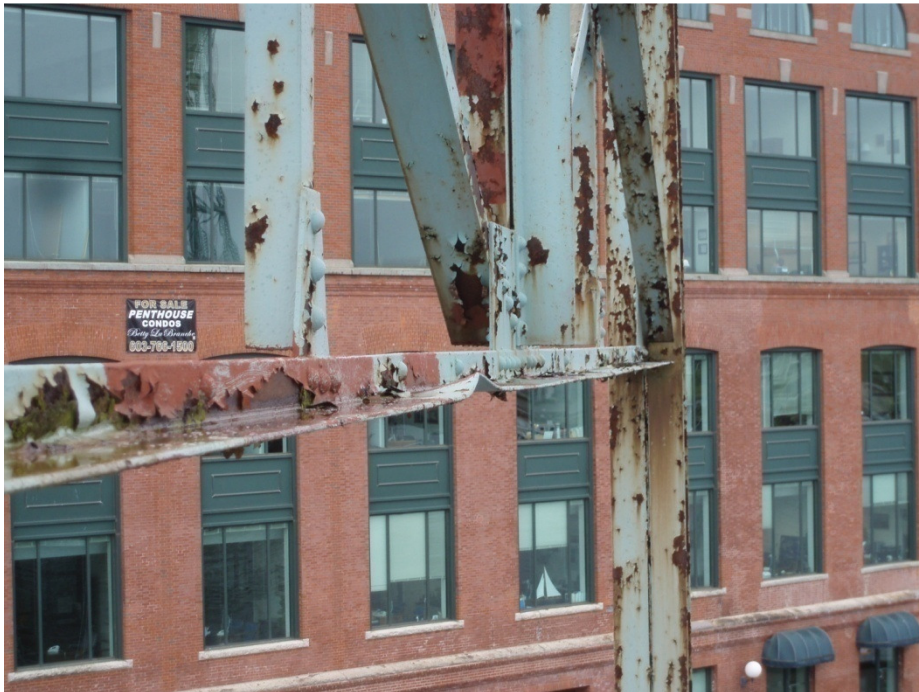
Photo 1.22: Bottom strut of sway frame at Span 1, Panel Point 2. Impact damage on the bottom struts of several sway frames.

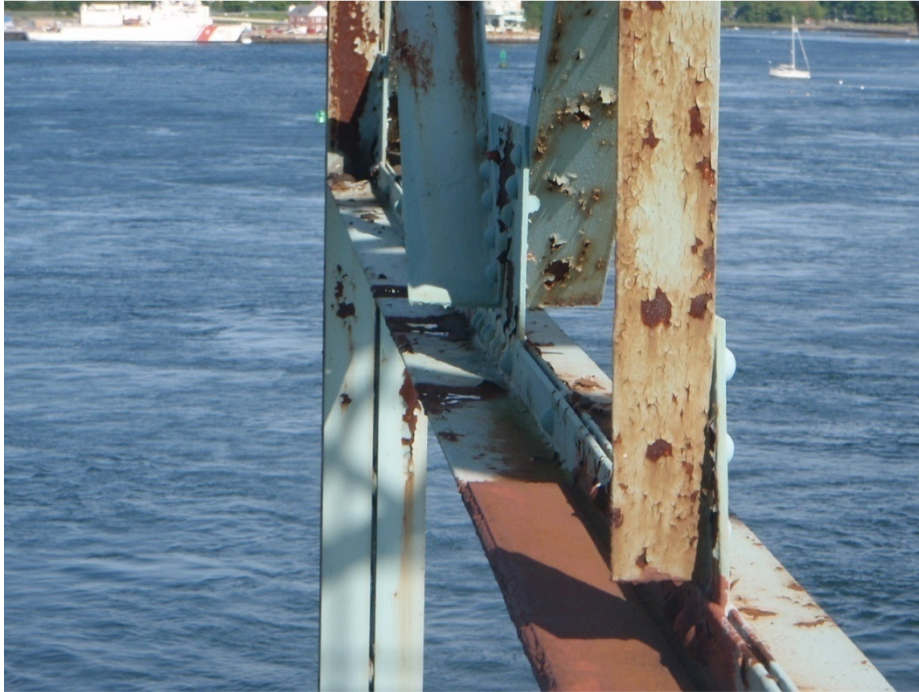
Photo 1.23: Span 2, sway frame at Panel Point 7. Corrosion holes and welded repair plates on bottom strut of sway frame.

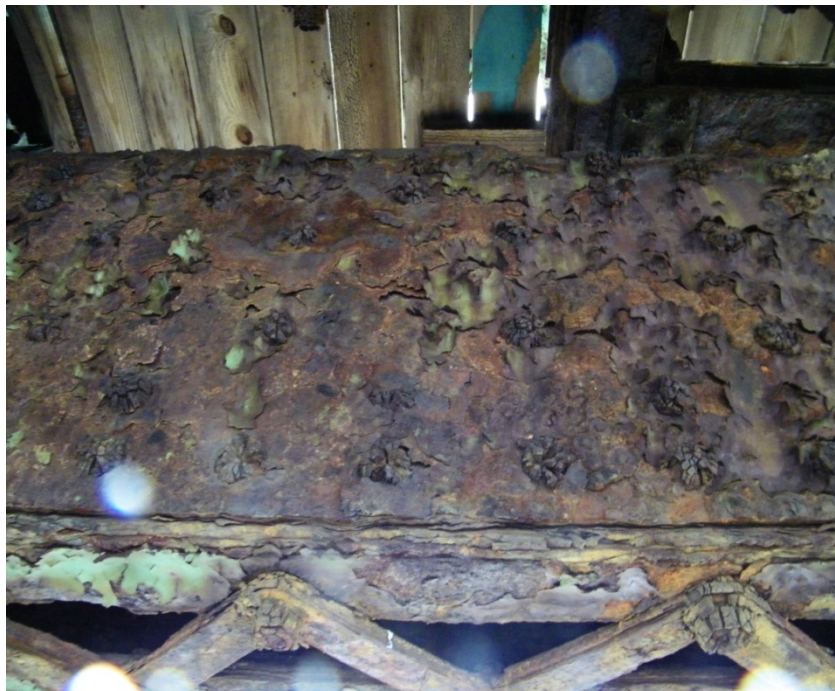
Photo 1.24: Span 2, West Truss Bottom Chord L5-L6, interior face. Laminar corrosion on all surfaces.

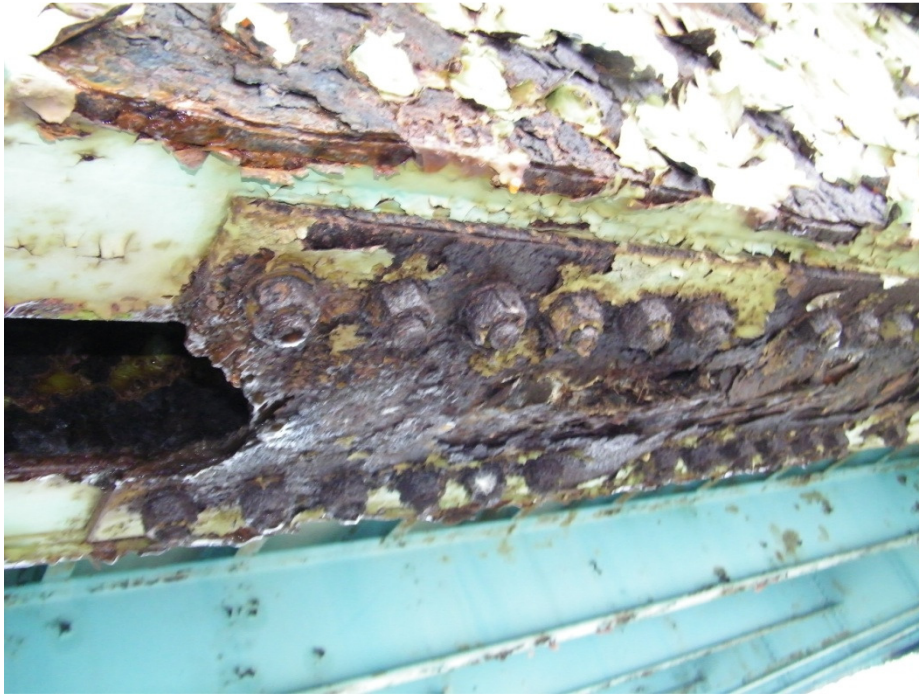
Photo 1.25: Span 3, Heavily deteriorated bottom batten plate on East Truss Bottom Chord L2-L3 near L3. Plate has almost 100% section loss.

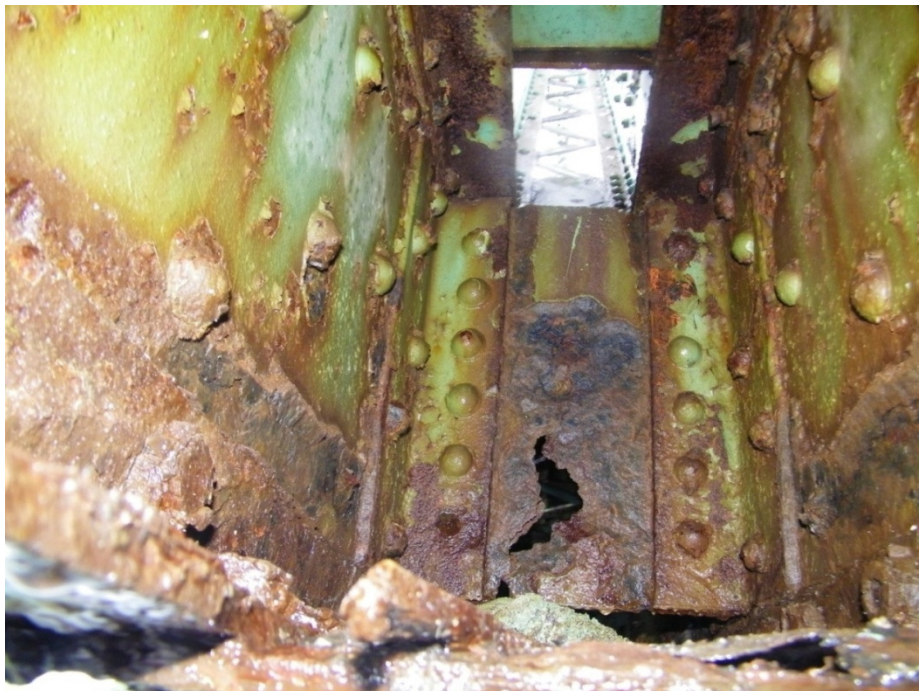
Photo 1.26: Span 3, East Truss Bottom Chord L8-L9 at L9. Corrosion on inside face of webs and flanges.

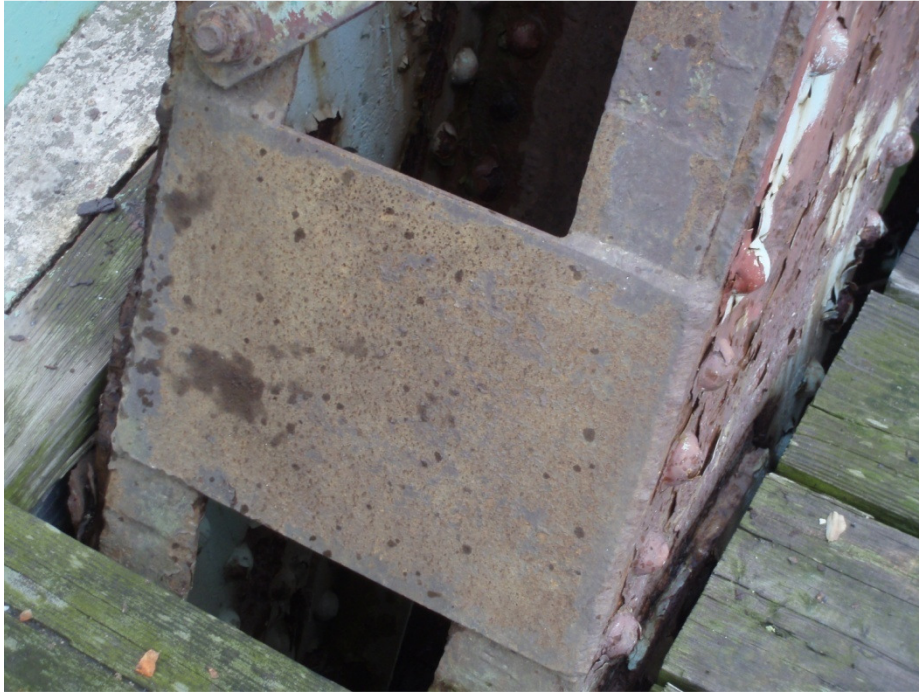
Photo 1.27: Span 1, East Truss Diagonal L2-U3 at sidewalk deck. Welded batten plate on diagonal and laminar corrosion on diagonal webs.

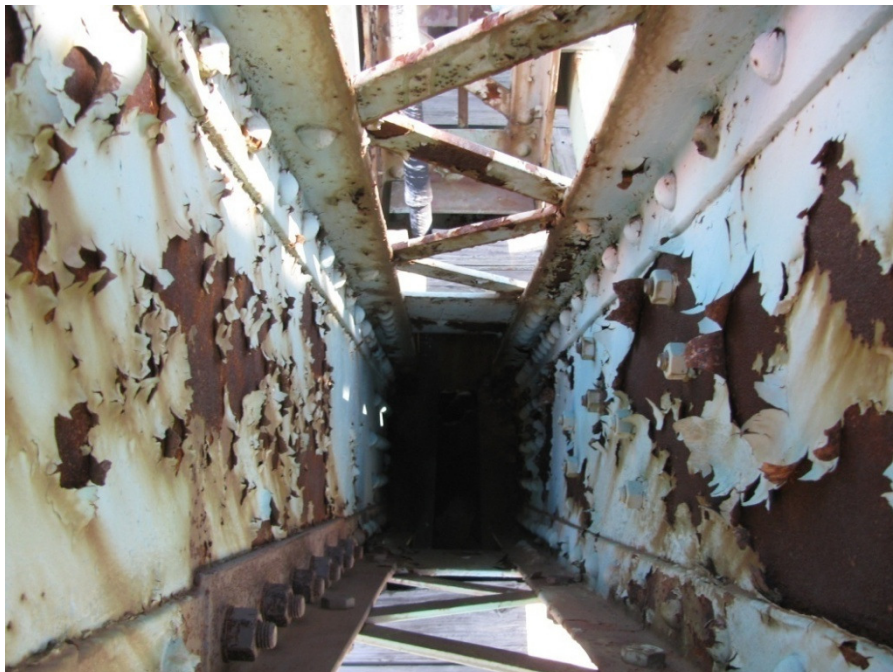
Photo 1.28: Span 1, West Truss Diagonal U7-L8. Inside of diagonal near L7. Peeling paint and surface rust on webs and flanges. Lower left angle has been spliced with a new angle. Splice is bolted to web and welded to original portion of the flange angle.

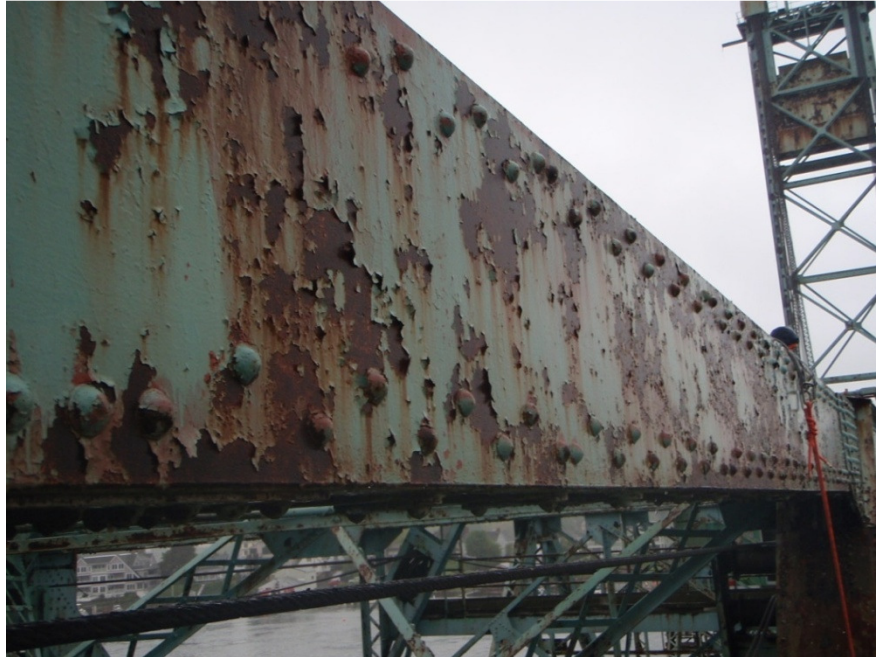
Photo 1.29: Span 2, East Truss Top Chord U0-U1. Surface rust typical on chord webs.

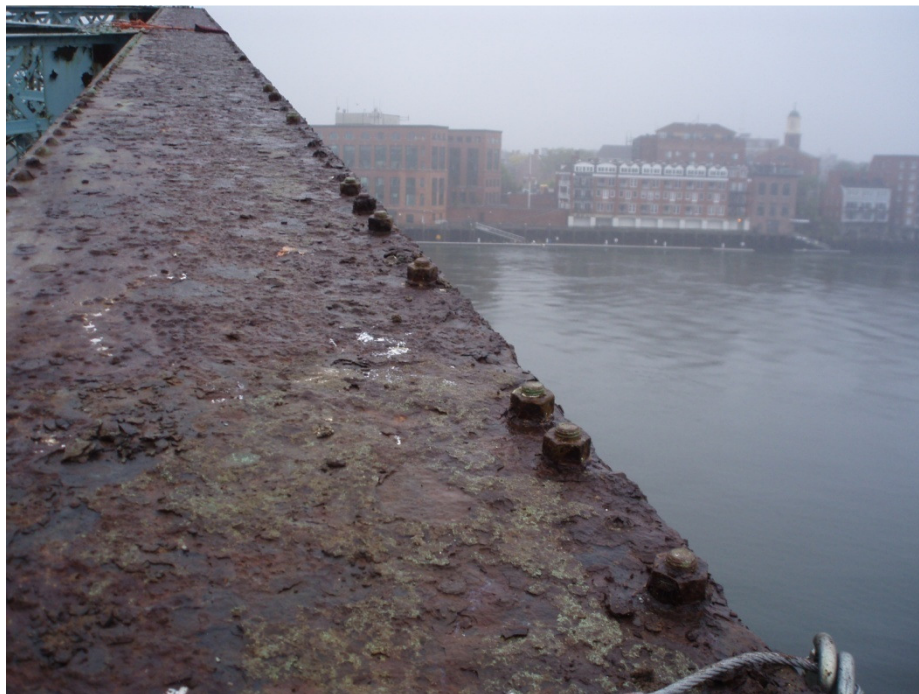
Photo 1.30: Span 3, West Truss Top Chord U8-U9. Heavy laminar corrosion and pitting on top flange of top chord, typical throughout.

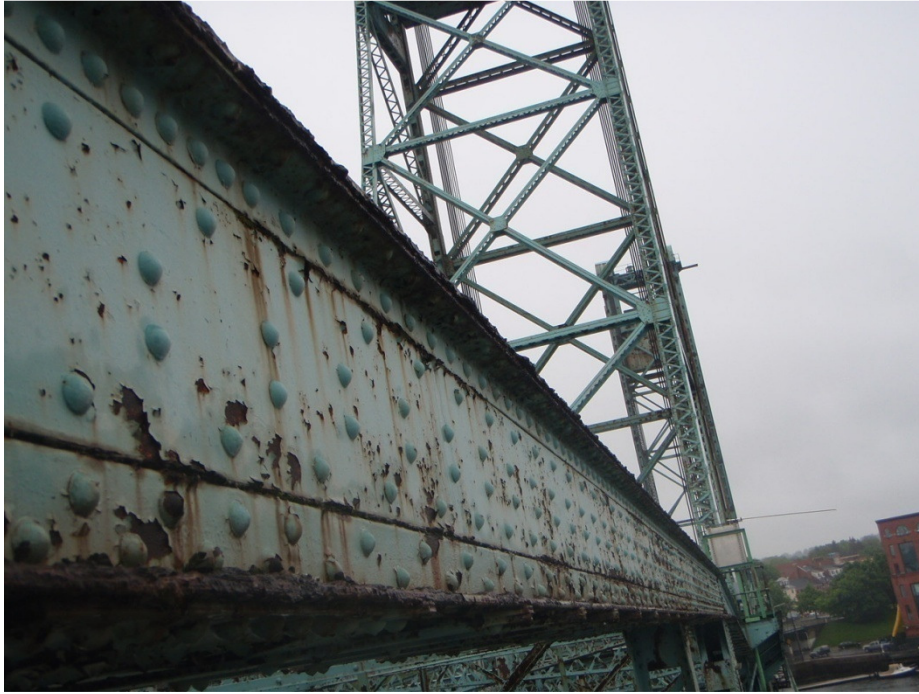
Photo 1.31: Span 3, West Truss Top Chord U4-U5. Pitting and corrosion on web and bottom flange.

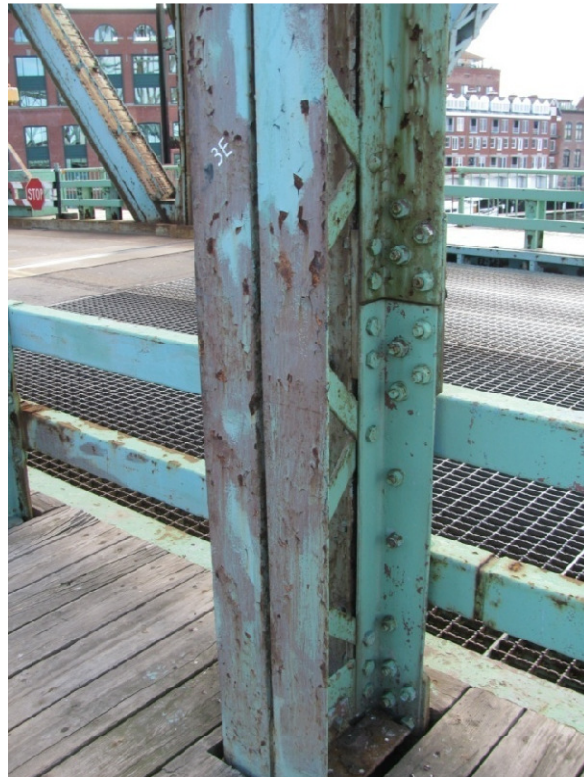
Photo 1.32: Span 2, East Truss Vertical L1-U1. Truss flange spliced with additional bolted angles and plates.

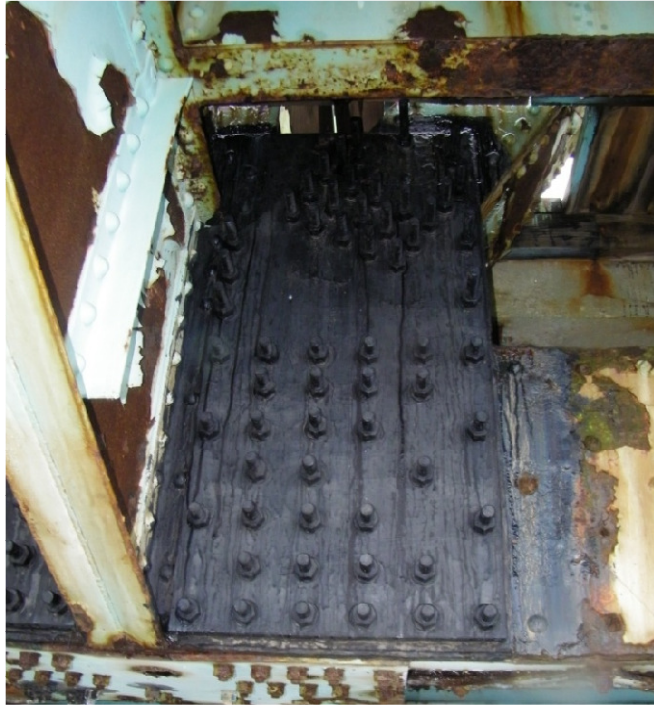
Photo 1.33: Span 1, East Truss Bottom Chord, Gusset Plate L4, exterior side plate. Typical gusset plate retrofit.

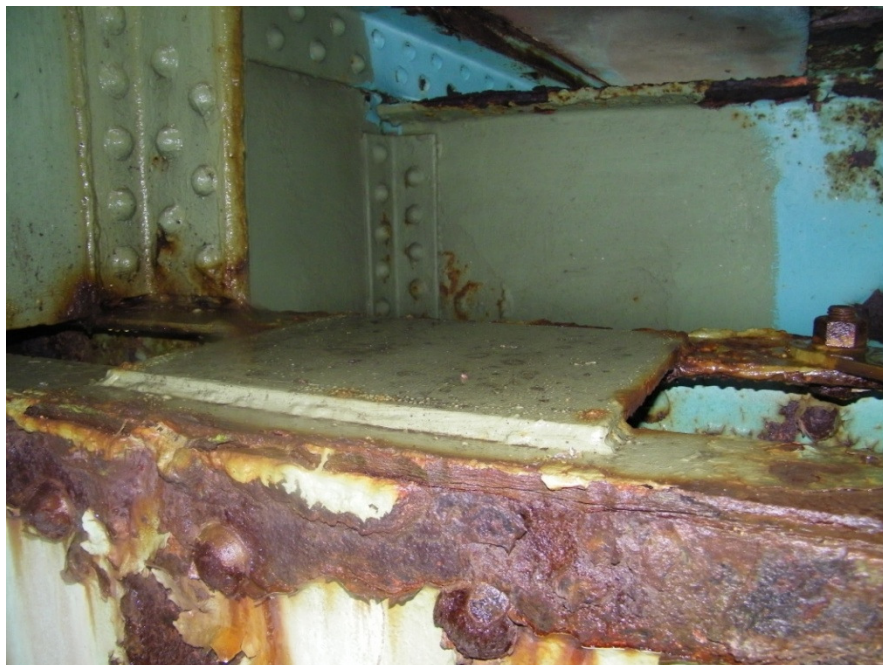
Photo 1.34: Span 3, West Bottom Chord. Batten plate welded to top flange of L9-L10 near L9. Laminar corrosion on top 2" of web. Also note welded batten plate on vertical web on upper left hand corner of photo.

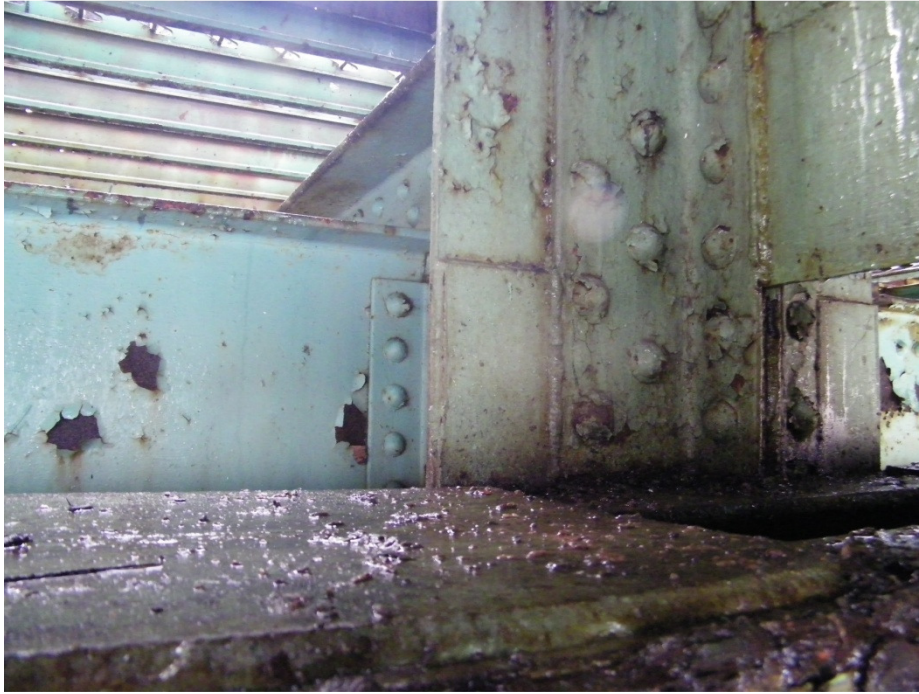
Photo 1.35: Span 2, West Truss Gusset L9. Batten plate is welded to Bottom Chord L9-L10, gusset plate is welded to truss Vertical L9-U9. Batten plate is welded to vertical flanges.

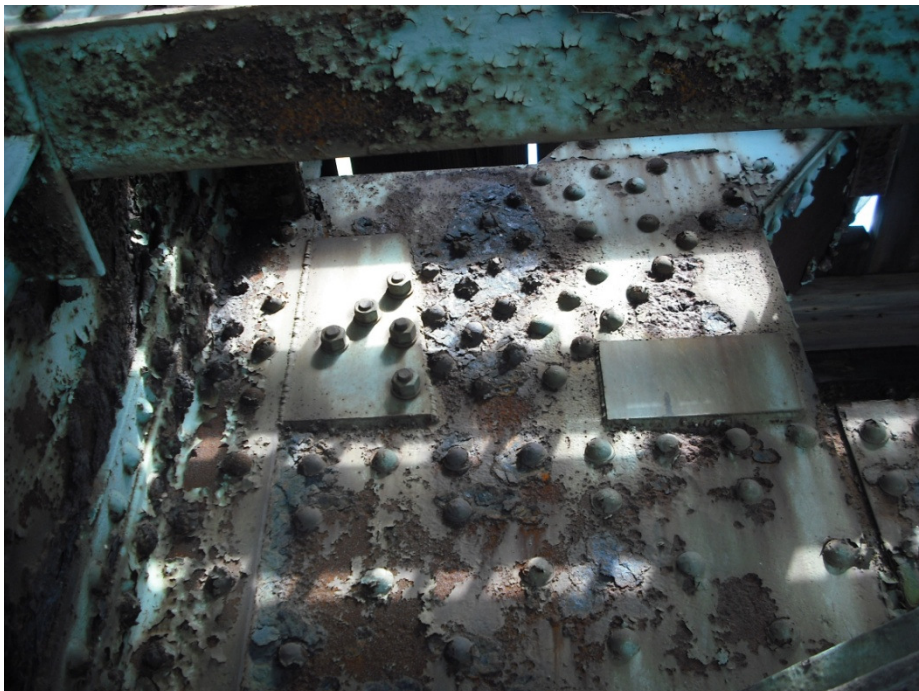
Photo 1.36: Span 2, Gusset L4E, Interior side plate. Welded repair plates on gusset.
